1368 Finn Ave

Jerry Payne  
Axium Inspections, LLC  
1700 Lincoln St STE 3030  
Denver, CO 80203  
303-831-1202  
8/3/2015

<b>Date:</b> 8/3/2015	<b>Time:</b> 2:00 PM	<b>Report ID:</b> AX15080314JAP
<b>Property:</b> 1368 Finn Ave Lone Tree, CO 80124	<b>Customer:</b> Debbie Bailey	<b>Real Estate Professional:</b> None

### **17 • Limited Mold Inspection**

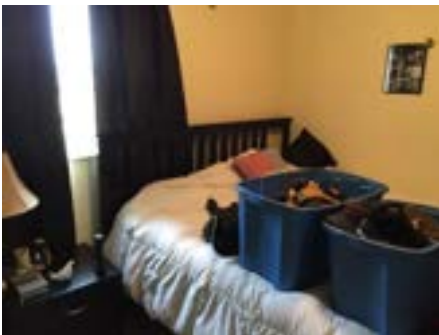
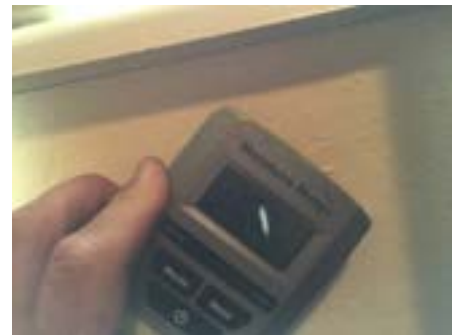
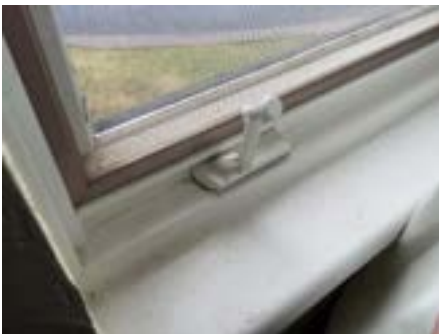
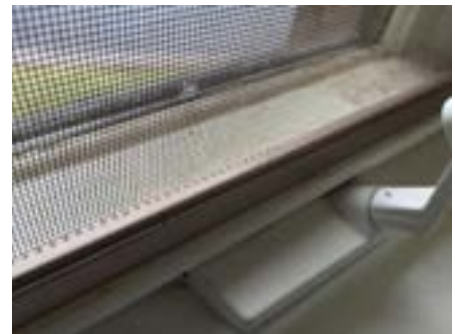
17.01.3 • No visible moisture intrusion was present in the bedroom with the crawlspace access.

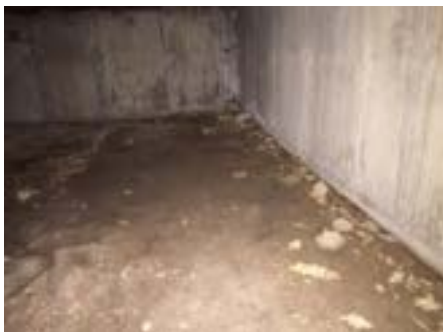
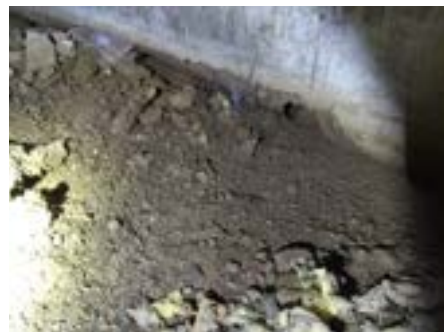
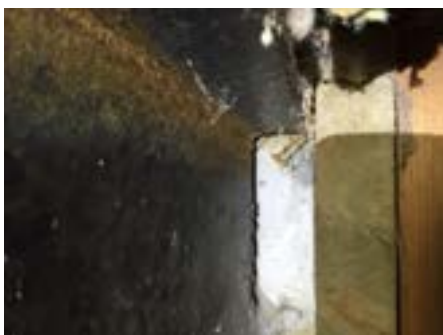
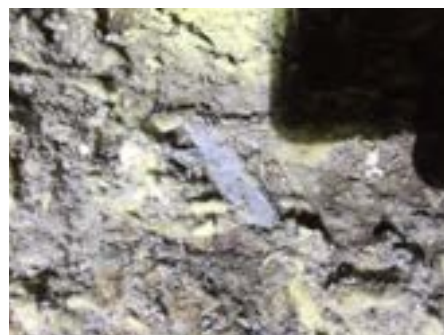
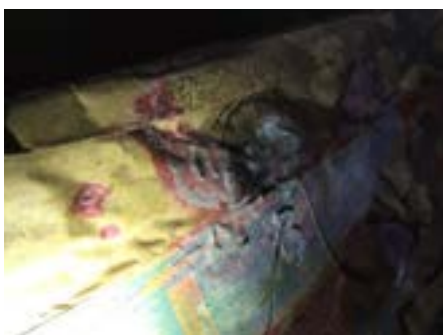
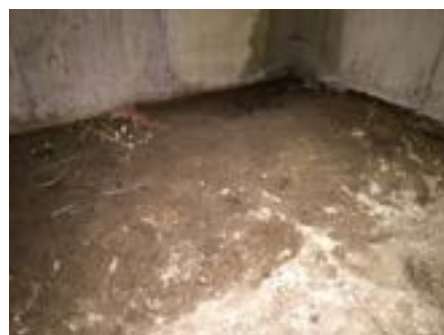
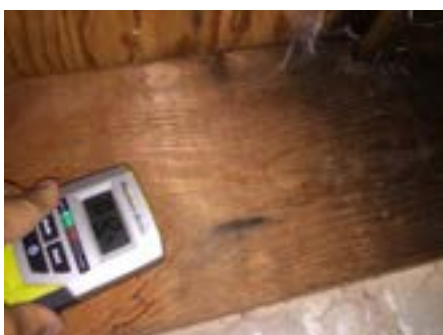
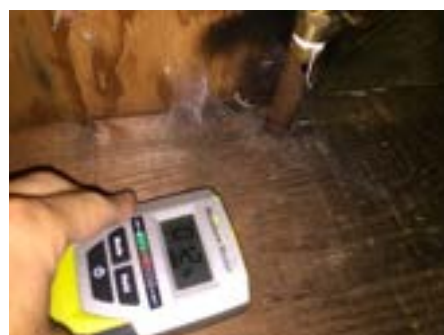
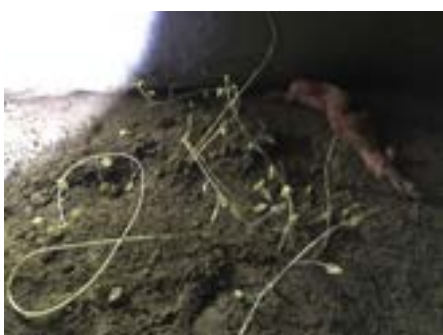
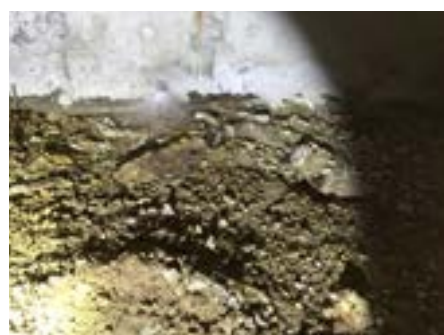
17.01.4 • Both crawlspaces had exposed dirt floors and did not have a proper vapor barrier. The dirt is wet from ground water moisture intrusion. Ventilation of the crawlspace was not present and the humidity levels are higher than normal. Inspector recommends the installation of an active humidistat ventilation system that would operate during times of moisture intrusion of high humidity. Evidence of water pooling in both crawlspaces was present at the time of the inspection. A qualified contractor should evaluate and repair or replace as necessary and according to current standards.

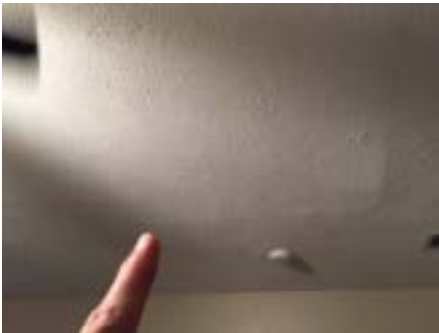
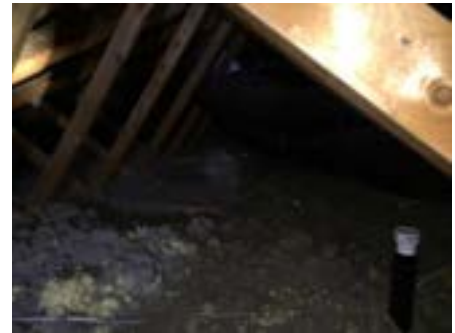
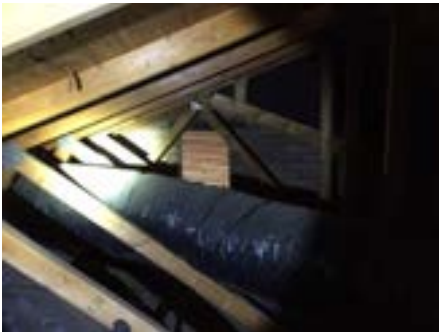
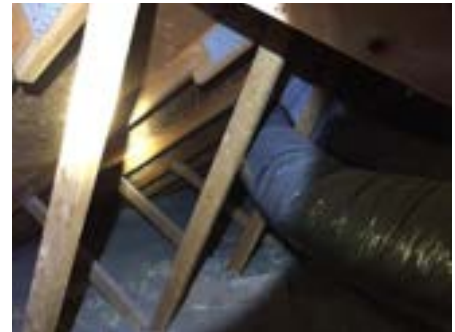
17.01.7 • Ceiling in the master bedroom has signs of previous repairs from previous moisture intrusion. No signs of moisture was present in the attic.

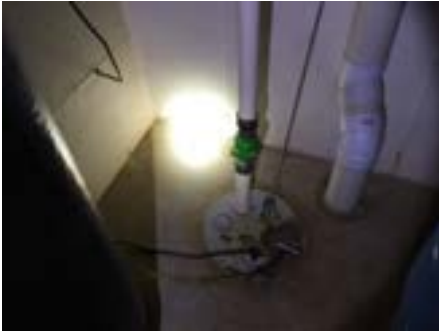
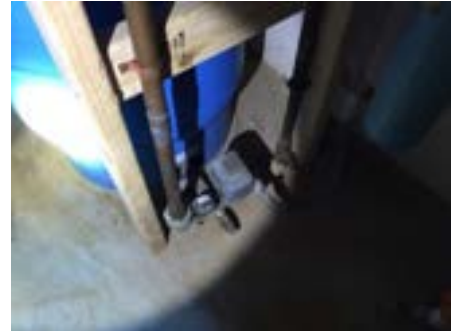
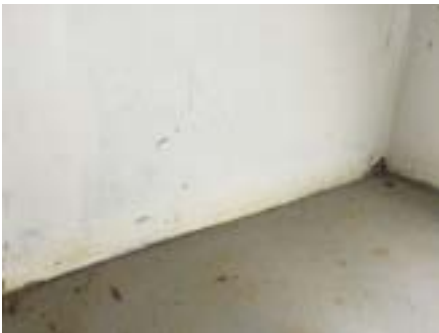
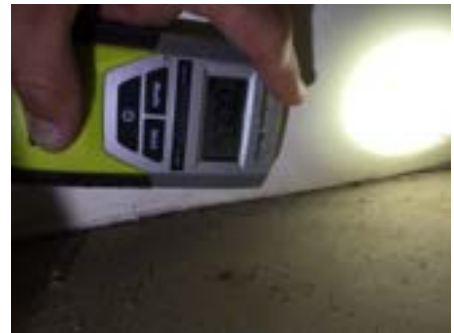
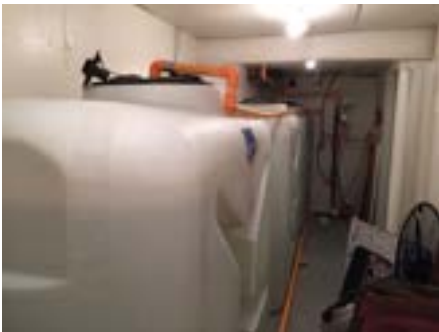
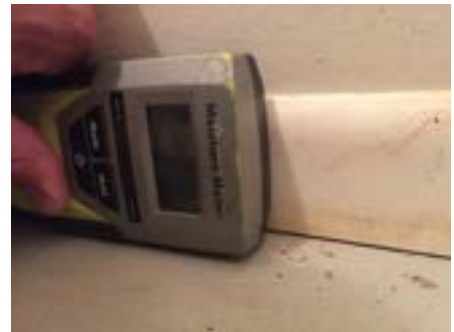
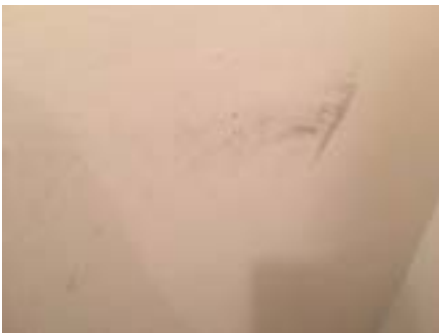
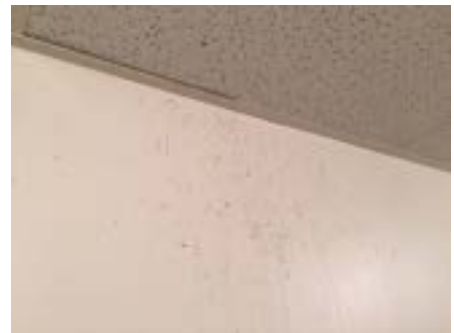
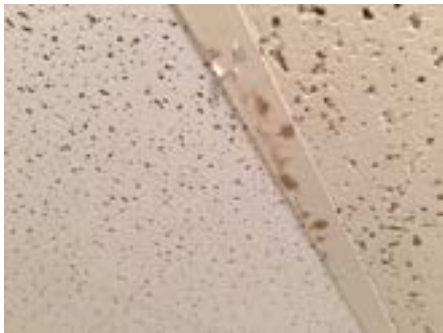
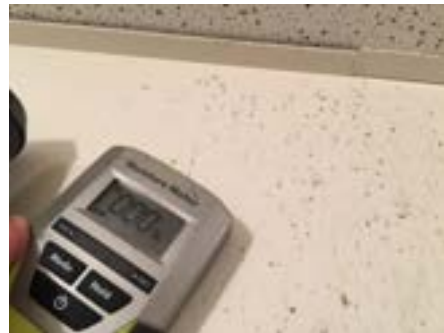
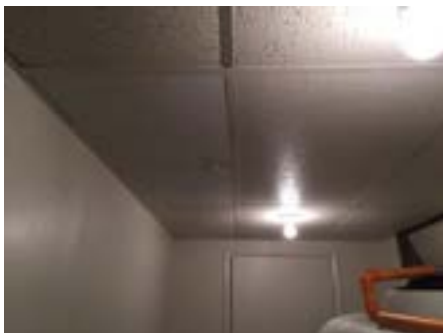
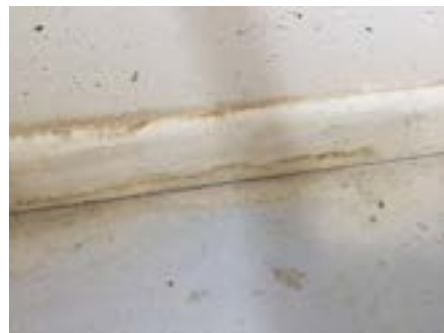
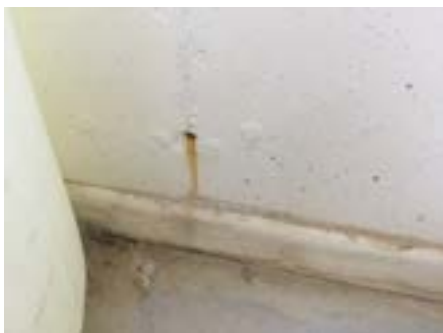
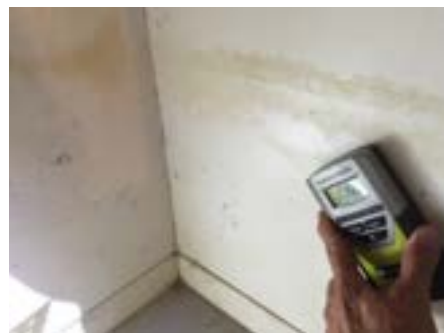
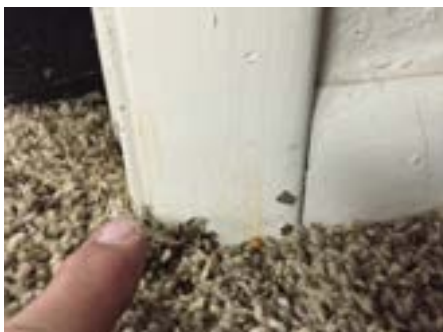
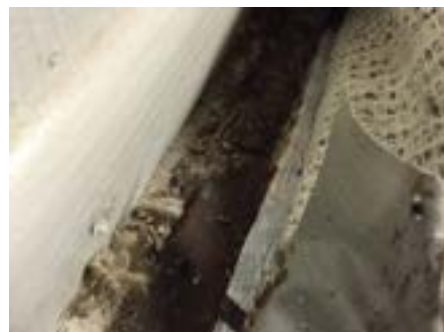
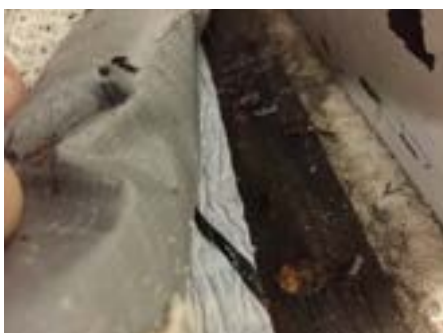
- 17.01.8 • In the basement were signs of previous moisture intrusion and staining on the baseboards and walls in several areas. No moisture was present at the time of inspection was present. Moisture signing was present on the ceiling tiles in several areas. The carpet tack strips show signs of moisture intrusion and are deteriorated from moisture in several areas. A mold spore air trap sample was taken from the basement .
